GR712RC memory production test coverage and usage constraints

Technical note 2022-03-18

Doc. No GR712RC-TN-0002

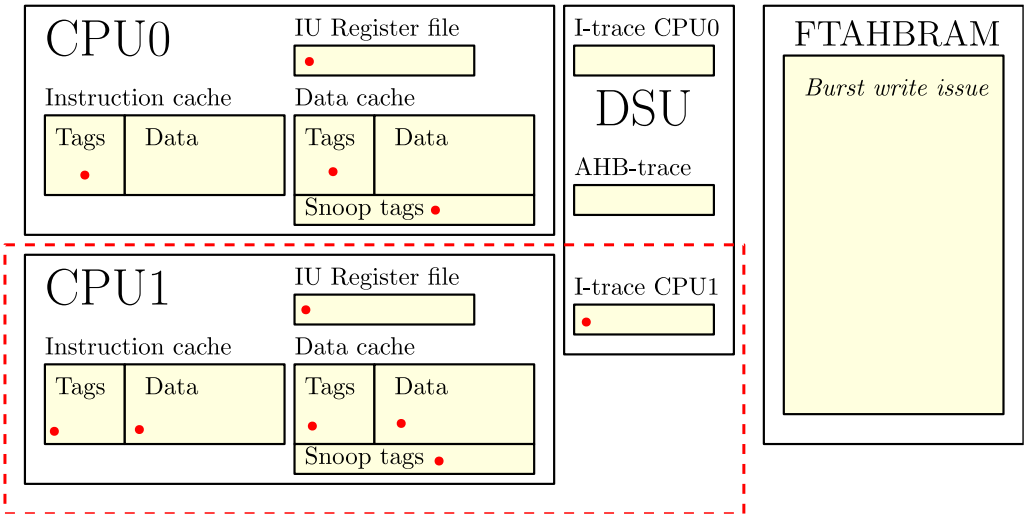
A graphical overview of memory macrocells in the GR712RC is given in Figure 1. The dashed rectangle indicates memories with incomplete address coverage in production test program revision 3. The red dots indicate memories with incomplete *bit-state coverage* (see section 5.2 for definitions). Other memories, such as the FPU registers, the 16-entry MMU TLB and FIFOs are not shown since they are implemented as hardened flip-flops [RD1], not memory macrocells. In the remainder of this Technical Note, the term "memories" will mean "memory macrocells".

Figure 1 Overview of memory macrocells in the GR712RC. Red dots: Not all bit-states tested. Dashed rectangle: Address decoding not fully tested. FTAHBRAM: Has burst write issue.

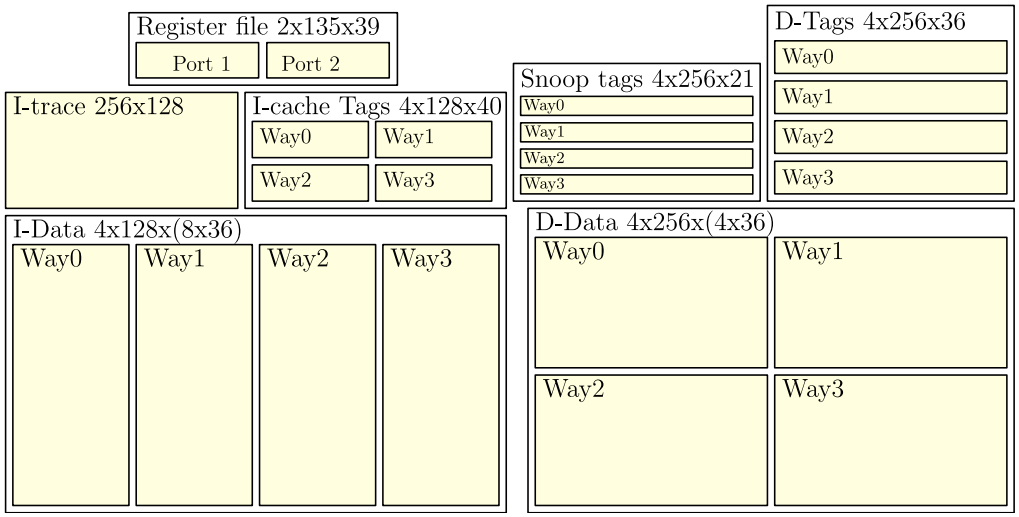
Figure 2 Comparison of the relative sizes of memories specific to one CPU (either CPU0 or CPU1). The area of each shaded rectangle is proportional to the number of bits it contains.

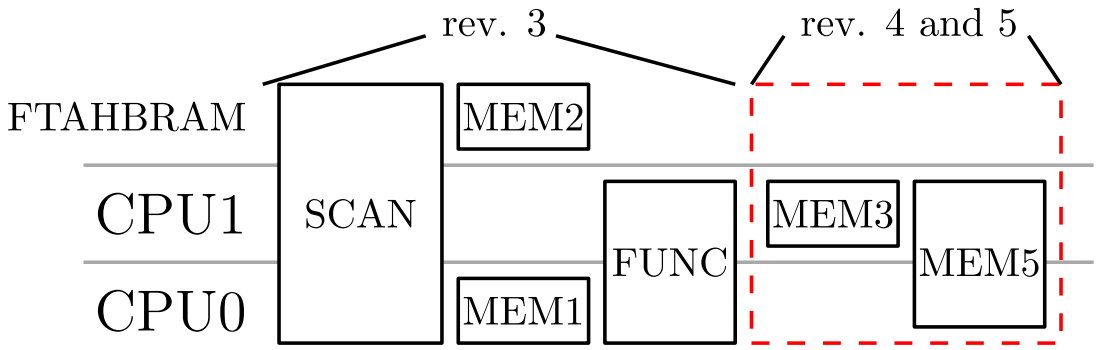
Figure 3 Simplified overview of subtests in production test program revision 3-5.

As indicated by Figure 3, the main coverage issue in production test program revision 3 is the lack of dedicated tests for CPU1 memories. The only subtest with partial coverage of CPU1 memories is FUNC. A second issue is the coverage gap between the MEM1 and MEM5 subtests for CPU0 memories. This section quantifies the incomplete coverage of the FUNC subtest for CPU1 memories and the MEM1 subtest for CPU0 memories.

6. MEM5: Tests of IU register file and cache tag memories that cover the gaps in the MEM1 and the MEM3 subtests. The MEM5 subtest was added in revision 5 of the production test program.
